Use of Biochar in Live Streams and Lakes on Mine, Municipal and Private Lands

J. Patrick Barber Acer Environmental, LLC.

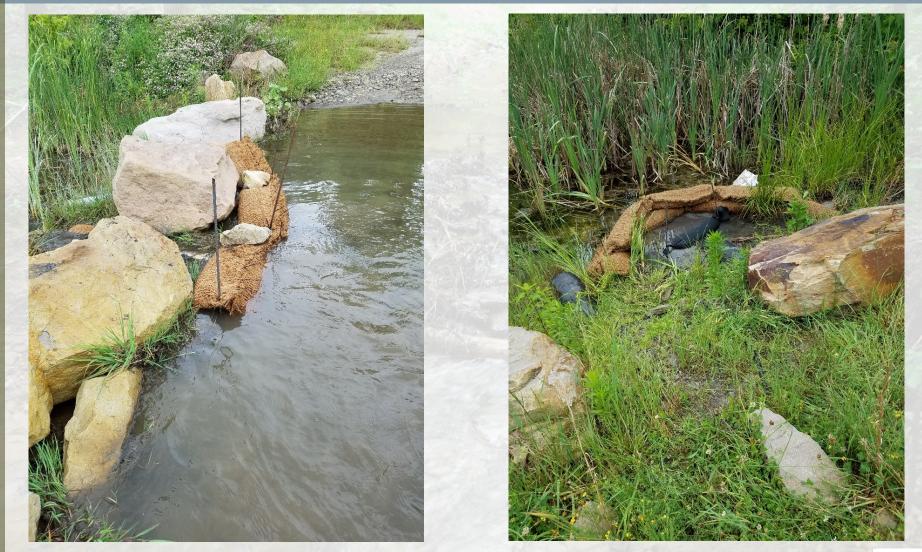
Biochar Bags in Coir Fabric at Two Different Pond Outlets

- Project included treating water leaving two treatment ponds that had Aluminum levels that were 9.7 mg/l.
- WVDEQ limits for Aluminum are 4.0 mg/l limit.
- Initially added Biochar to the water but no adsorption occurred.
- Discovered pH was below pH of 3.

- Caustic soda was added to the water to neutralize the pH.
- Once the caustic brought the pH up above a pH of 4, the levels of Aluminum in the water started to reduce.
 - When the pH reached neutral and above the levels of Aluminum in the water were reduced to 0.3 mg/l.
 - Socks/bag lasted in the ponds for over 8 months, initially.
 - Fouling due to a flocculant created from adding the caustic soda to the water eventually clogged up the bags, preventing the flow of water through the bags.
 - Biochar bags/socks utilized a rice grain biochar with one-third of the material being shredded wood. We used the wood because the small biochar tended become compacted. The wood was used to aid in allowing water to move through the material.
 - Replacement bags have been in place for five years without problems. One set had to be replaced because it was washed away by a storm.

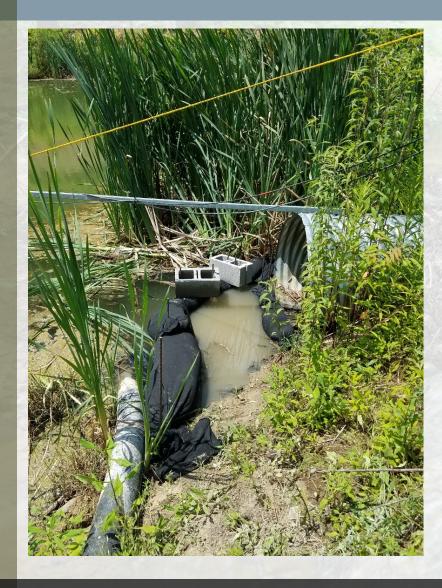
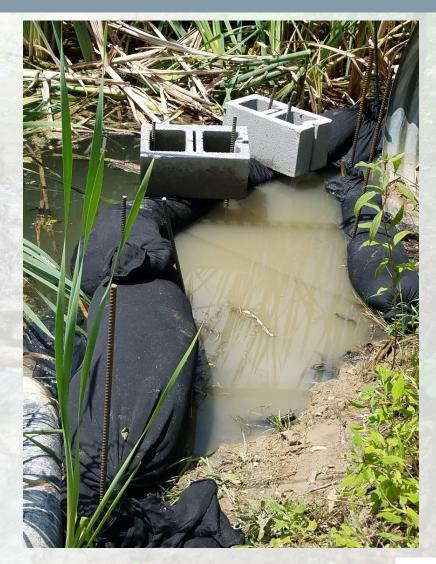
Biochar Bags at Pond Outlet

- Water leaving three different treatment ponds had Selenium levels that were over 10 mg/l.
- WVDEQ limits for Aluminum are 4.7 mg/l limit.
- We utilized a series of socks/bags wrapped around the outlet that were 1foot by 20 feet were stacked on top of each other at the outlet of each pond.
- Additional 20 bags that were 8 inches by 48 inches were floated through out the ponds.
- Selenium levels were reduced to less than 2 mg/l.
- The bags placed in the pond stopped an algal bloom that was occurring in approximately 3 weeks of installation.
- Bags are still in the water and had lasted for over 5 years keeping the Selenium levels below required levels.
- We recently replaced bags because they were lost to a storm.

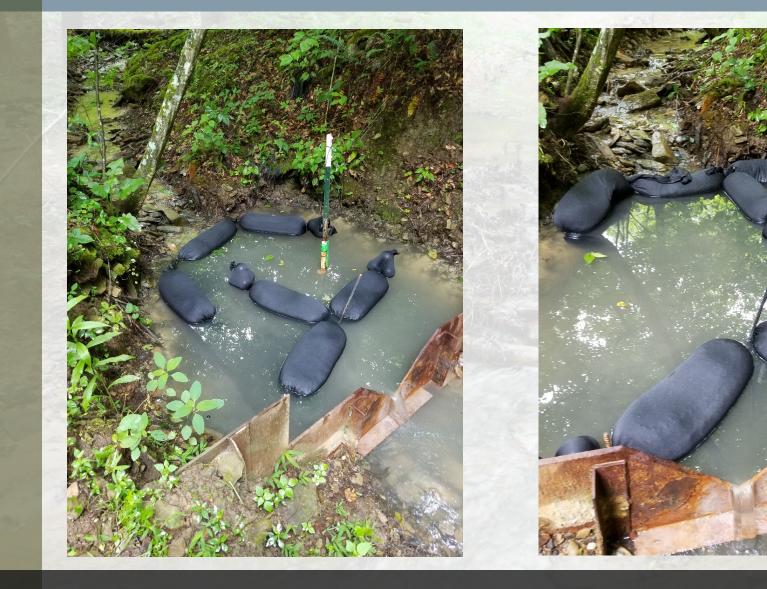
Biochar Bags in a Pond Outlet

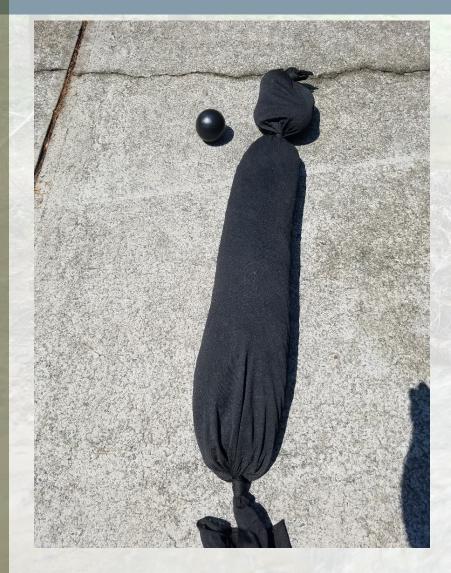
- Utilize silt sock.
- Can be wrapped in coir fabric to filter off larger particles.
- Floats are plastic cannon balls or any type of plastic/rubber ball.
- Attach paracord to bottom and tie it off to a concrete block.
- Located mostly at the inflow of the pond.
- Can be located over bubblers or other water dispersion device.
 - Can be attached to floating vegetation island.

Biochar in Silt Sock (8 inches by 48 inches)

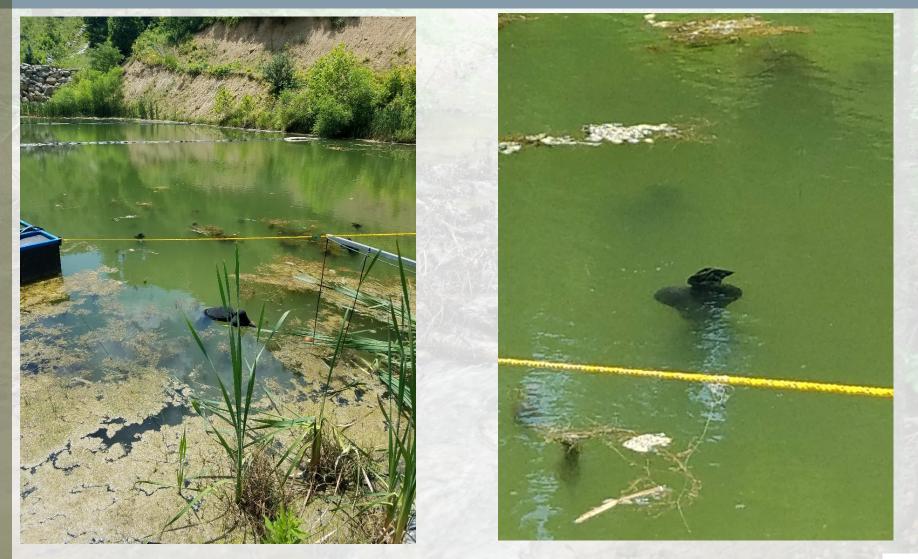
Biochar Tubes Floating in a Pond

- The socks/bags floated in a pond in WV stopped an algal bloom that was occurring in approximately 3 weeks of installation.
- A five-acre pond in South Georgia has over 500-acres of farmland upstream. Prior to treatment this pond had an algal bloom that started in May and ended at the end of October. Then in June of 2017 the owner installed 10 socks/bags that were 8 inches by 48 inches. The results are:

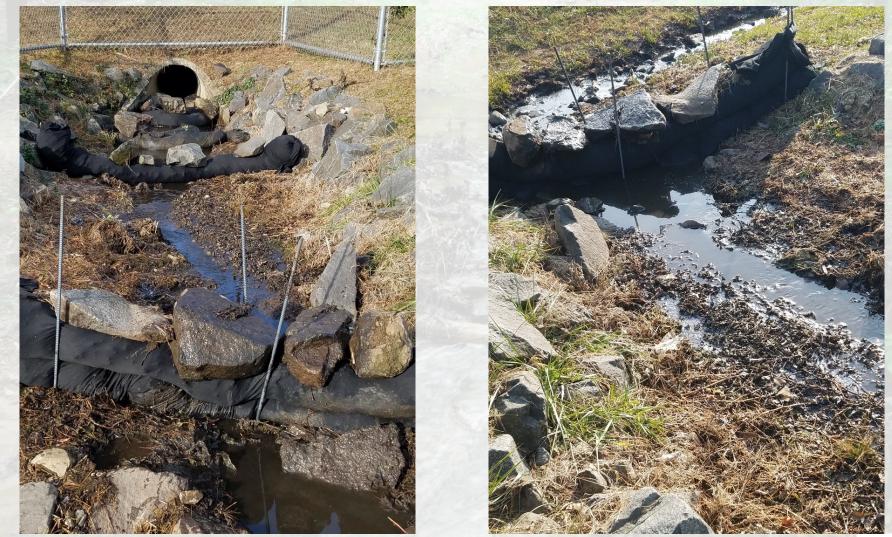
Biochar Bags Below Treatment Pond Outlet

- Installed Biochar at outfalls to two treatment ponds at a wood recycling facility and landfill.
- At wood recycling facility, initial sampling showed a reduction in BOD, phosphorus and nitrogen. The materials in the water causing the high BOD quickly overwhelmed the Biochar in the bags stopping it from adsorbing any additional materials.
 - The landfill site results found:
 - Phosphorus was reduced from 0.8 mg/l to 0.2 mg/l
 - BOD was reduced from over 35 mg/l to 4.0 mg/l
 - Escherichia coli was reduced from 2,419 CFU/100 ml to 344 CFU/100 ml
 - TKN was reduced from 4 mg/l to 2 mg/l
 - Not all of the water was filtered during this project.
